Smart I-V Curve Diagnosis key value

Smart I-V Curve Diagnosis for fast fault recovery and easy O&M

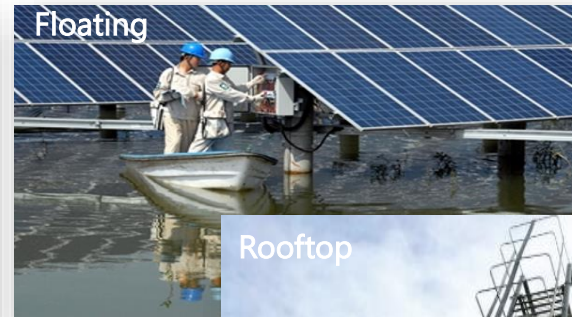
Floating

- Complex site
- Inconvenient transportation

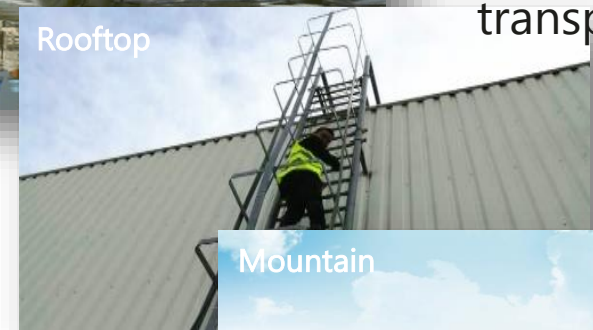
Rooftop

- Dispersed
- high altitude risk

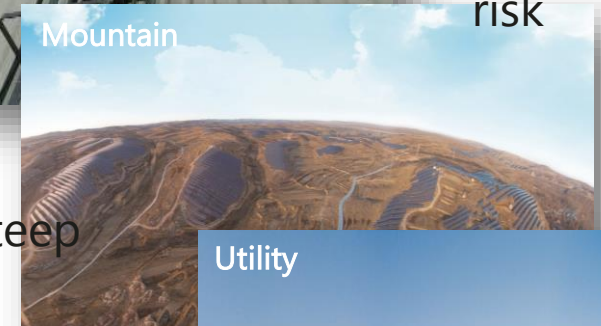
Mountain

- Rugged and steep
- Dispersed

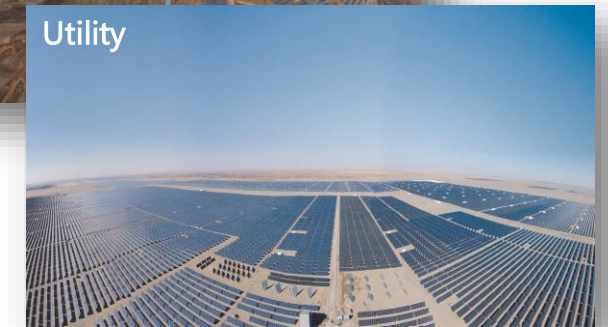
Utility

- Large scale and wide area
- Workload is heavy

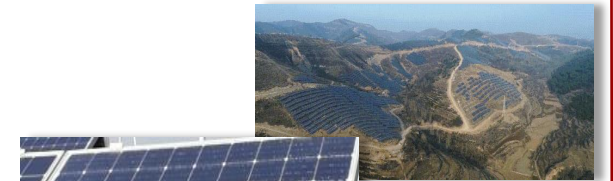
Glass Breakage

Address: Asia
Scale: 50MW
Number: 168436 panels
Area: ~1 sq.km.
Grid connect time: 29/7/2017

Diagnosis string: 3960
Breakage string: 65
Breakage ratio: 1.65%
String Yield Loss Estimated: ~5%
Security: **The insulation doesn't comply with the IEC standard, which may cause electric shock**

Fault Rectification Prediction save RMB 2.71 million in 20 years(~0.008 \$/W)

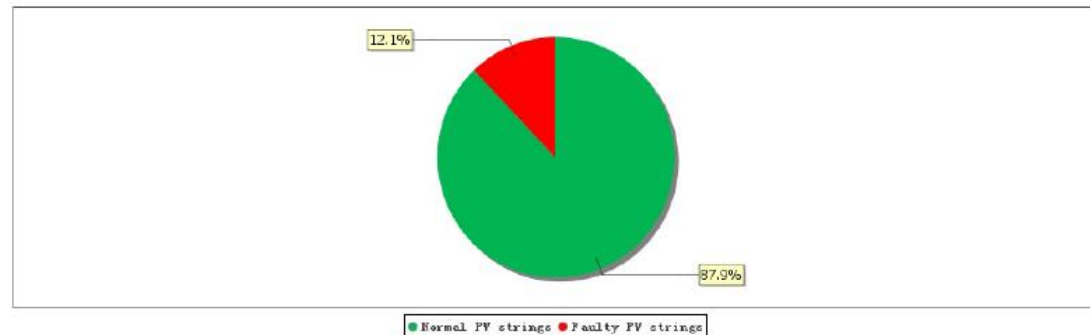
Failures Number Ratio

1. Evaluation of the PV String Failure Rate

In total, 9496 PV strings are scanned in this task. Faulty PV strings: 1149. Total failure rate: 12.1%.

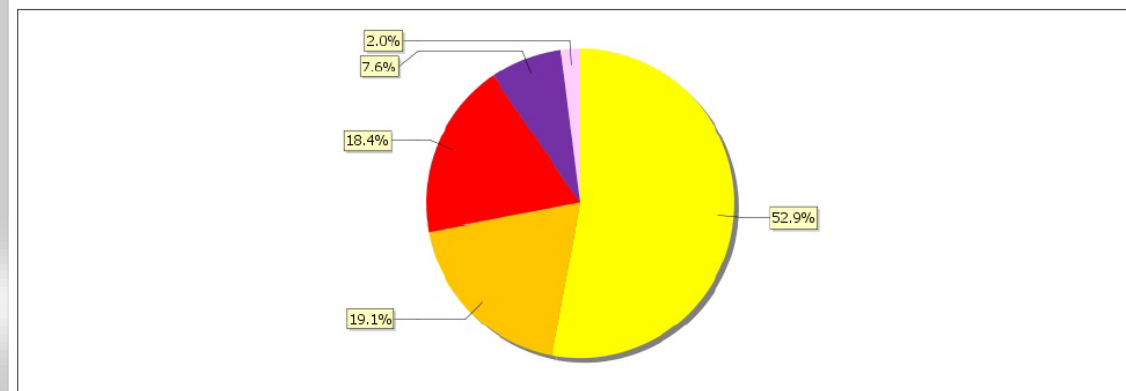
Failure Types Ratio

2. Fault Type Analysis

In total, 24 SmartLoggers are scanned in this task. 1149 PV strings are faulty. The distribution is as follows:

The common faults are:

- 1) PV module output current abnormal (shade/glass breakage/hidden crack), Percentage: 52.9%
- 2) Current mismatch in the PV string (shade/dust/PV module current inconsistent), Percentage: 19.1%
- 3) PV string open circuit (PV string breakage/PV string configured by mistake), Percentage: 18.4%

First 3 common faults vs. total faults: 90.4%

Failure	Ratio	Cause
PV module output current abnormal	52.9%	Shade, glass breakage or hidden crack
Current mismatch in the PV string	19.1%	Shade, dust or PV module current inconsistent
PV string open circuit	18.4%	PV string breakage or PV string configured by mistake
Abnormal curve near MPP in the PV string	7.6%	Hotspot, hidden crack or glass breakage
PV string voltage abnormal	2.0%	diode short circuit, PV module invalid or PV module quantity incorrect

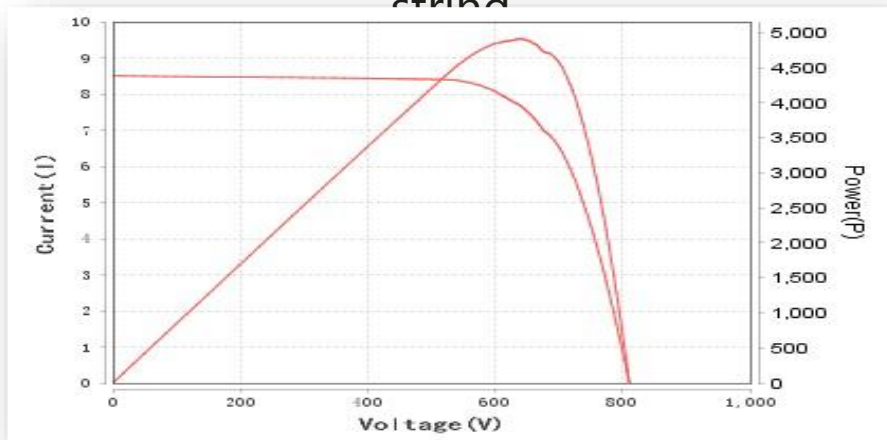
Diagnosis report: PV String I-V Curve Details

Abnormal curve near MPP in the PV

string

Isc[A]	8.51	Imp[A]	7.69	Pmax[W]	4908
Voc[V]	810.80	Vmp[V]	638.5	Abnormal curve near MPP in the PV string (hotspot/hidden crack/glass breakage)	
Irr[W/m²]	967.15	Temp[°C]	64.62

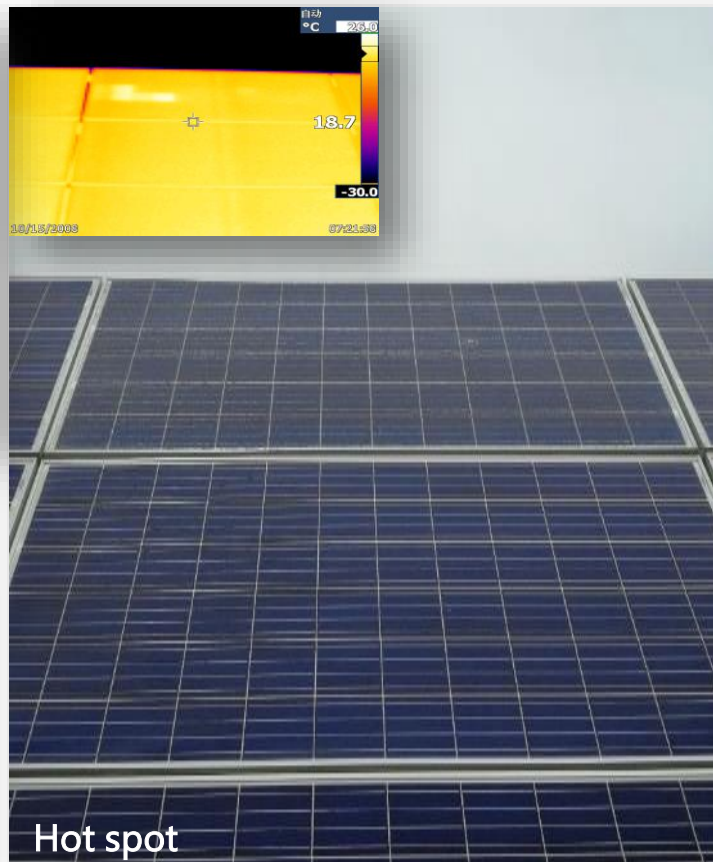
Actual situation on site
A module has hot spot

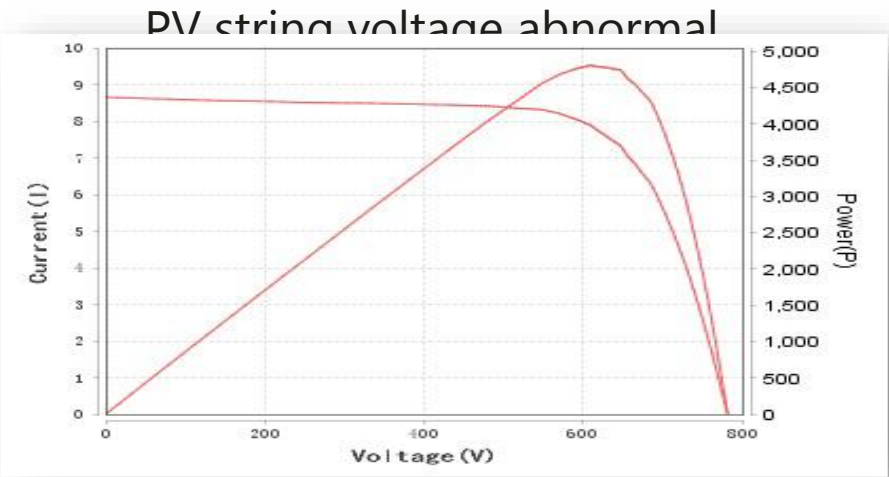
Diagnosis report: PV String I-V Curve Details

Isc[A]	8.65	Imp[A]	7.88	Pmax[W]	4808
Voc[V]	782.00	Vmp[V]	638.5	PV string voltage abnormal (diode short circuit/PV module invalid/PV module quantity incorrect)	
Irr[W/m²]	967.15	Temp[°C]	64.62		
Huawei C

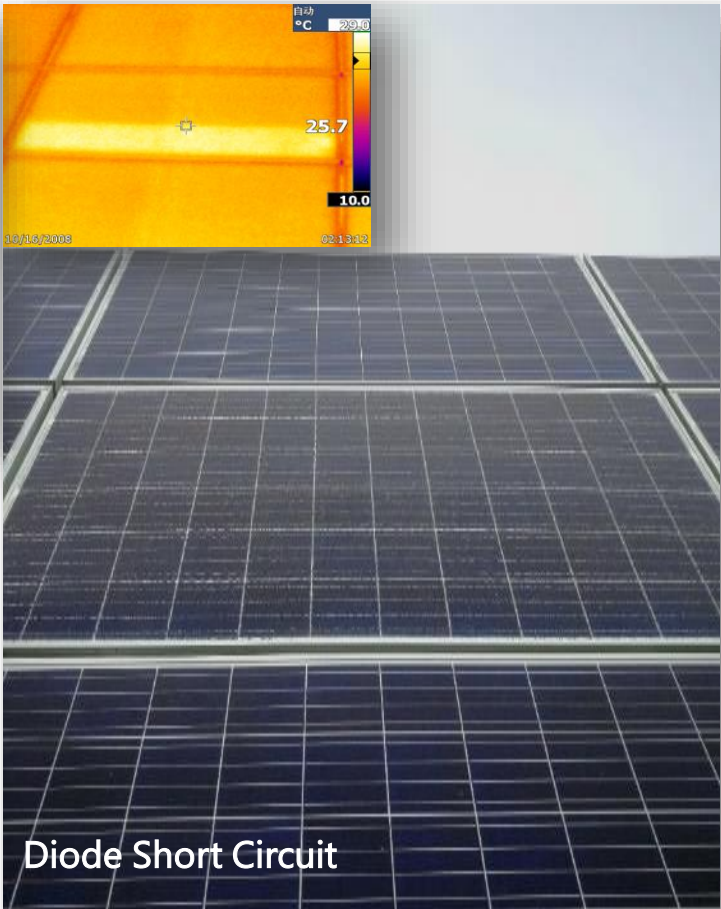
Actual situation on site A module has diode short circuit

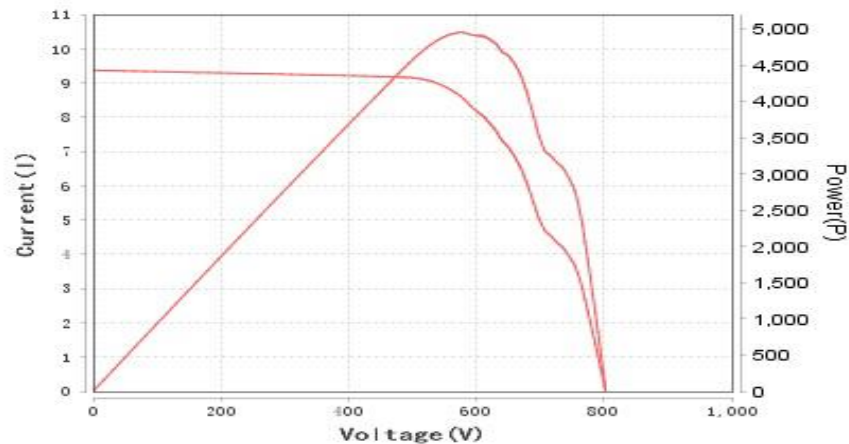
Diagnosis report: PV String I-V Curve Details

PV module output current abnormal

Isc[A]	9.37	Imp[A]	8.62	Pmax[W]	495.7
Voc[V]	782.00	Vmp[V]	575.3	PV module output current abnormal (shade/glass breakage/hidden crack)	
Irr[W/m²]	967.15	Temp[°C]	64.62

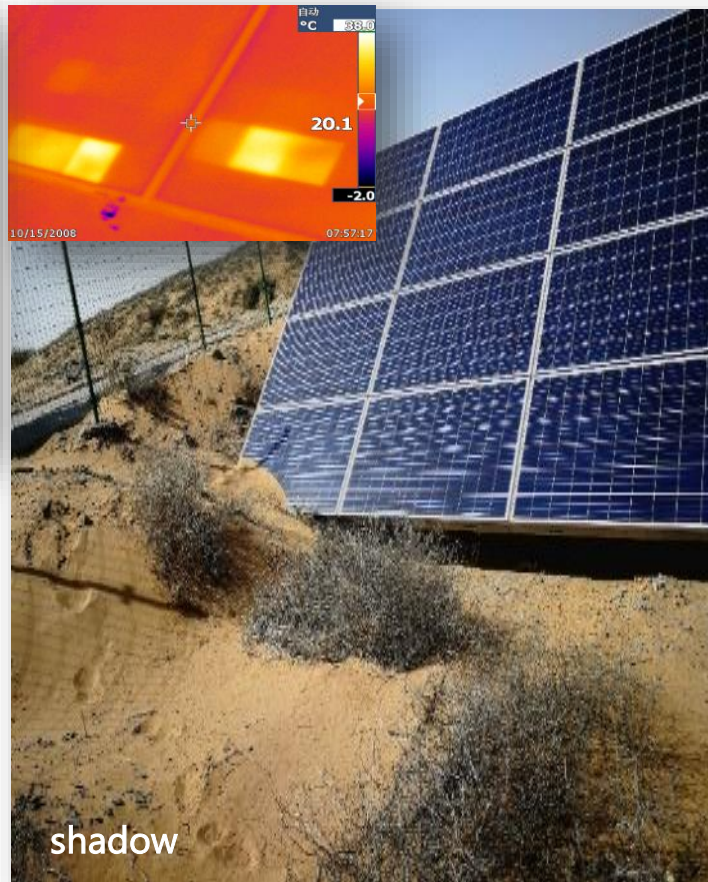
Actual situation on site PV modules have shadow
